OV-1

# ACCIDENT SUMMARY

MAJORS • MINORS • INCIDENTS • FORCED LANDINGS

NOVEMBER 1, 1961 TO OCTOBER 31, 1963

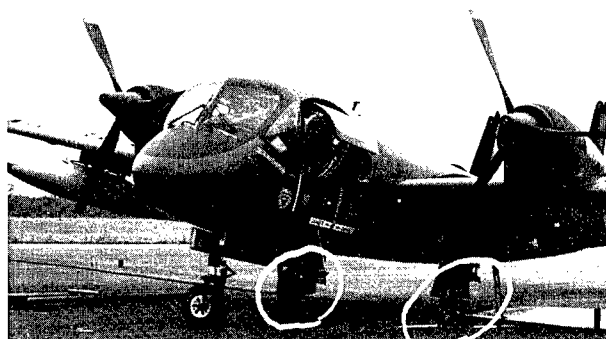
02791

THE ACCIDENT: Aircraft landed with high sink rate in nose-high attitude.

THE CAUSE: Student pilot performed power-off approach with low airspeed. IP failed to take corrective action in time.

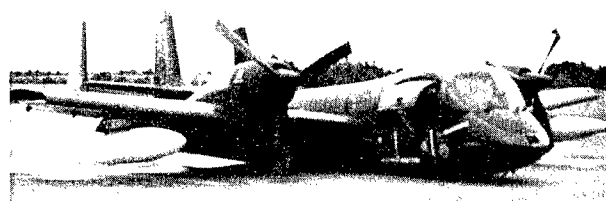
03844

THE CAUSE: IP accidentally moved gear handle instead of flaps lever during roll of touch and go landing.

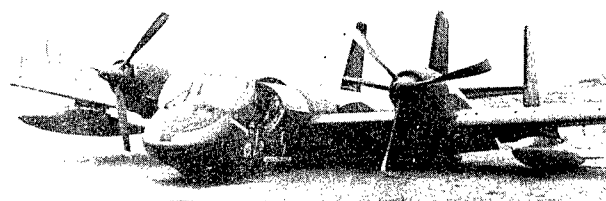
04106

THE CAUSE: High, fast downwind approach and use of reverse thrust before touchdown.

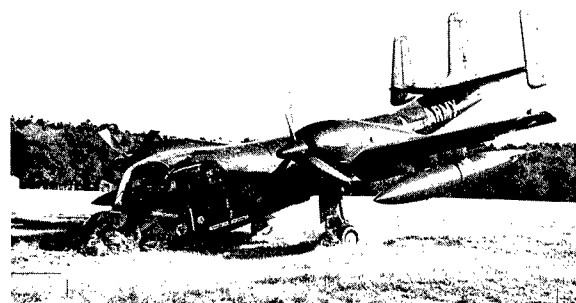
04200

THE ACCIDENT: Nose gear collapsed during landing roll on sod strip. Pilot applied full reverse thrust at touchdown and nose gear drag brace failed, allowing wheel to retract.

THE CAUSE: Materiel failure.

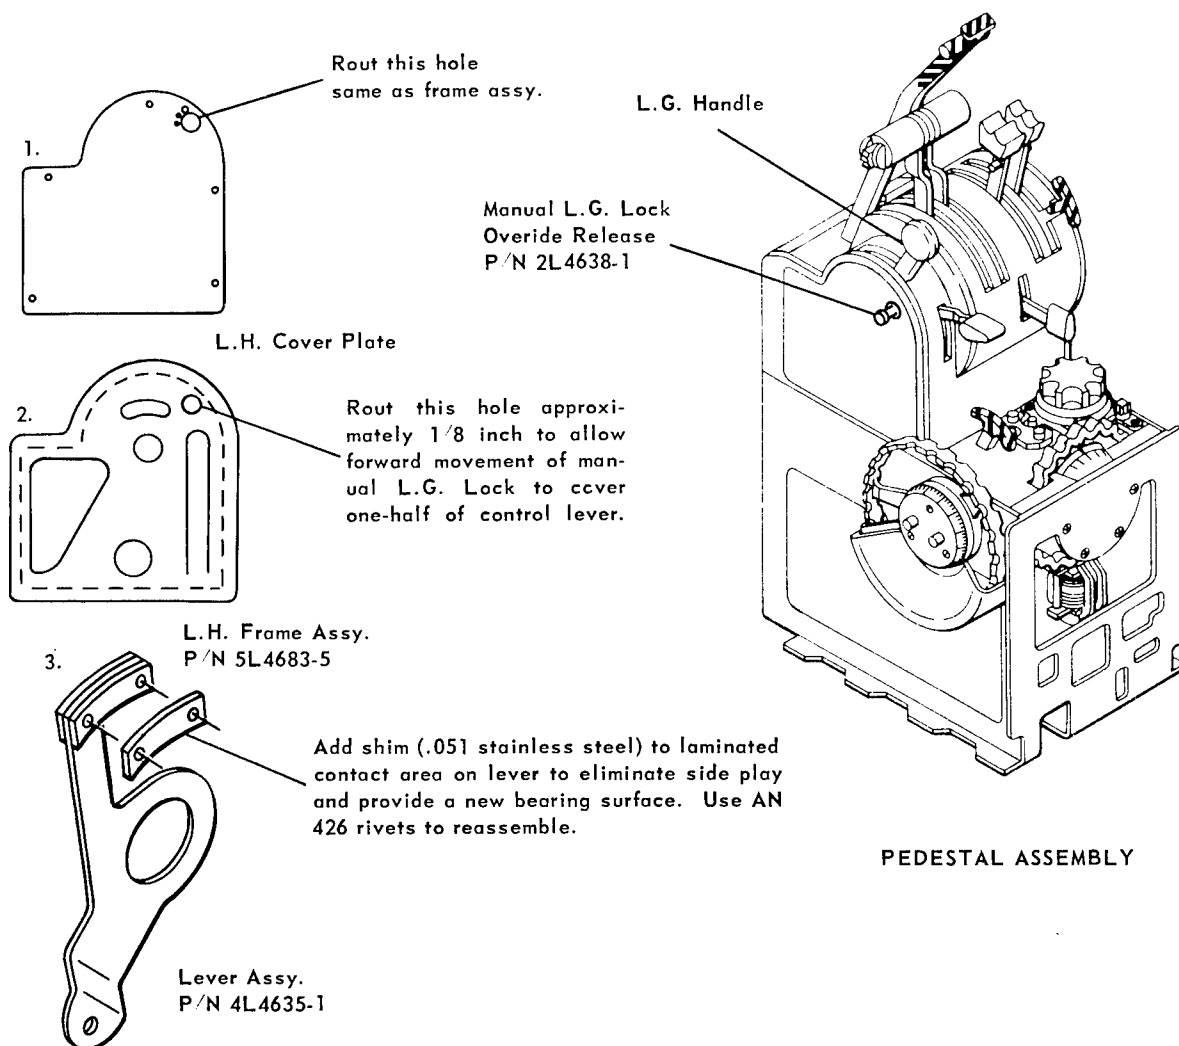
Due to several inadvertent landing gear retractions, MWO 55-1510-204-34 1, 21 Nov 1961, was issued covering inspection of the landing gear lever. Inadvertent retractions can be caused by wear in various parts of the pedestal assembly. Repair as shown should be incorporated during the next scheduled periodic inspection.

**TO PREVENT INADVERTENT RETRACTION OF LANDING GEAR DUE TO WEAR AND TOLERANCE BUILD UP OF POSITION LOCK, REWORK THE THREE PARTS SHOWN BELOW.**
